Mitigation for Bats

Sue Searle BSc, PGDip,
MCIEEM

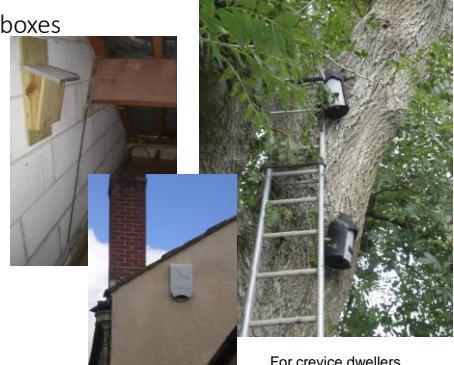
Bat boxes

For crevice dwellers

- Rarely adequate mitigation on their own due to their limited size/thermal mass
- Useful stop-gap (especially for demolition)
- Can be used within roosting area to provide 'crevice accommodation'
- Ideal simple means of enhancement...

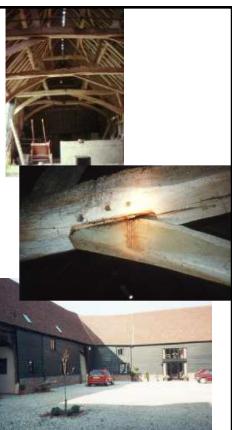
In this barn conversion the door of the barn openings were retained with recessed screens set back about 2m.

This retained the main bat roosts which were in the mortice joints around the old doors and provided sheltered access and flight area.

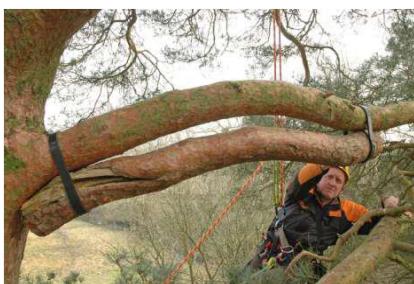
Monitoring results not known

- Nine trees were used to facilitate the bat roosts and bat boxes as compensation for loss of trees containing bat roosts.
- The re-erected roosts and bat boxes were assessed for security within the tree and usage by bats.
- The sections of timber containing the bat roost cavity/crack were cut, allowing adequate distance either side of the feature to avoid damaging it, and then lowered carefully to the ground. The section was then re-erected into a suitable tree as close to the original tree as possible. Consideration of orientation, height from ground, opening direction, surrounding habitat, and other environmental influences such as air temperature were taken into account when choosing the new location.
- In addition, safety to the public was considered when choosing the location and method of attachment to the tree.

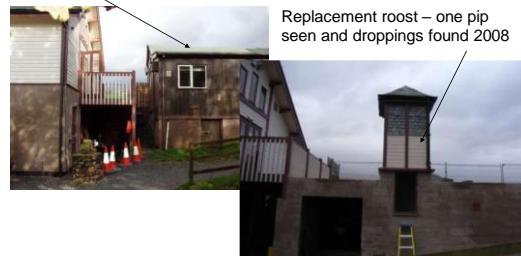
Common pip roost in old station building in Lake District 2005

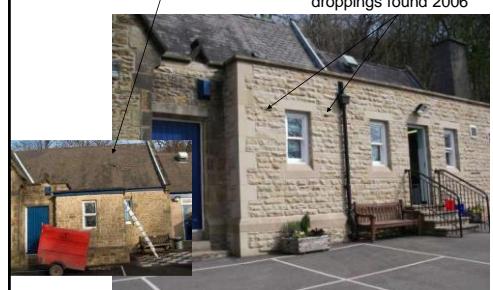
Pip droppings and one pip in school building 2005

Extension complete, access slots provided, pip droppings found 2006

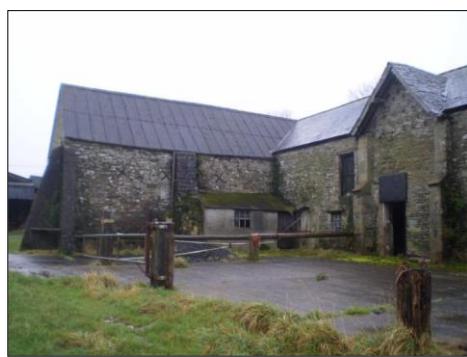
Stone farm buildings in West Devon. An underground stone walled drainage channel runs perpendicular to the southern elevation.

Conversion of barns into a single residential dwelling. Planning constraint that buildings should retain open space to the roof and therefore no loft spaces can be installed.

Drainage tunnel to be retained but moisture levels to be reduced to prevent rising damp in walls of barns.

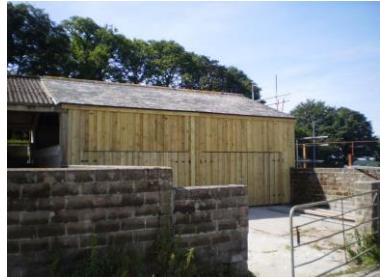
Case Study 1- Mitigation

Notes: Slate roof. Block walls clad in timber.

- Conversion of a nearby modern open-fronted agricultural building to incorporate a loft space dedicated for use by bat species.
- Installation of a moisture membrane over drainage tunnel to prevent surface run-off entering the tunnel, but retention of ground water flowing in.
- Works to roof structure of barns to commence during the period November to end of February. Works to drainage tunnel to be undertaken during the period May to the end of September.
